Manhole Inspection Summary

Manhole # S33K__010MH

Location Address: **rear 110 w conway st**

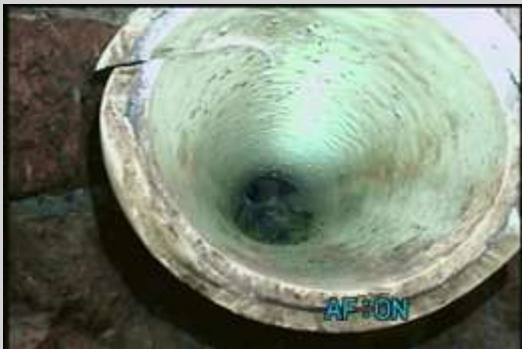
3 O'Clock Inflow

Pipe Height: 0 (in.) Direct

Pipe Material: **Clay** ☐ Pipe Lined

Invert Depth: **3.91** (ft.) Flow Characteristics: **None**

Deposits: ☒ None ☐ Mud ☐ Sludge ☐ Debris ☐ Grease

Infiltration: **None** Pipe Seal Cond: **Unknown**

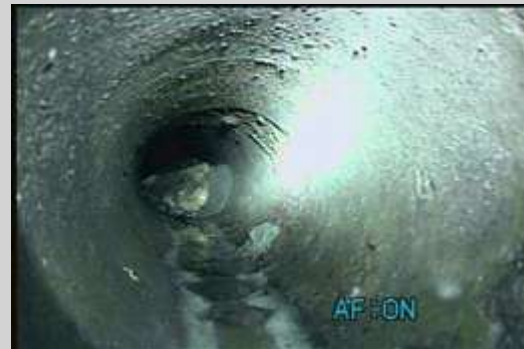
Drop In @ 3 O'Clock

Drop: **Outside Direct**

Drop Condition: **Open**
